Manhole Inspection Summary

Manhole # S31G__015MH

Insp Date: **11/12/08 9:58 AM**

Location Address: **front of university of md hospital**

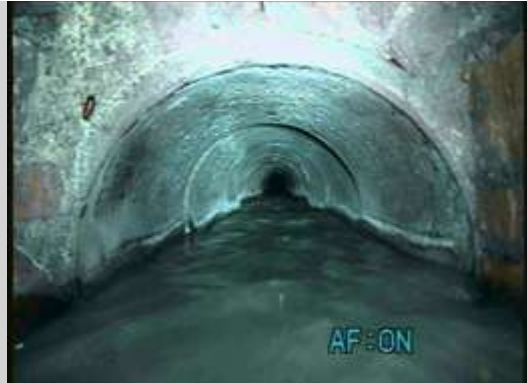
12 O'Clock Outflow

15 in. Circular Gravity Sewer
Pipe Out @ 12 O'Clock

Pipe Material: **Clay** ☐ Pipe Lined

Invert Depth: **25.75** (ft.) Flow Characteristics: **Fast**

Deposits: ☒ None ☐ Mud ☐ Sludge ☐ Debris ☐ Grease

Infiltration: **None** Pipe Seal Cond: **Unknown**

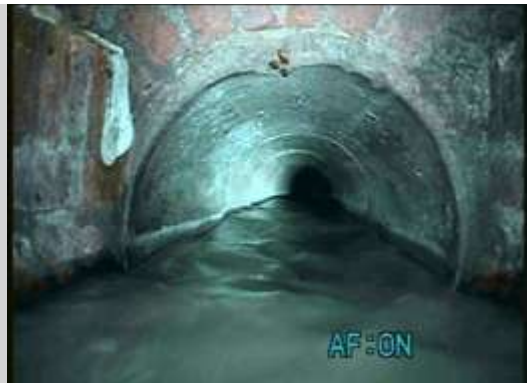
6 O'Clock Inflow

15 in. Circular Gravity Sewer
Pipe In @ 6 O'Clock

Pipe Material: **Clay** ☐ Pipe Lined

Invert Depth: **25.66** (ft.) Flow Characteristics: **Fast**

Deposits: ☒ None ☐ Mud ☐ Sludge ☐ Debris ☐ Grease

Infiltration: **None** Pipe Seal Cond: **Unknown**

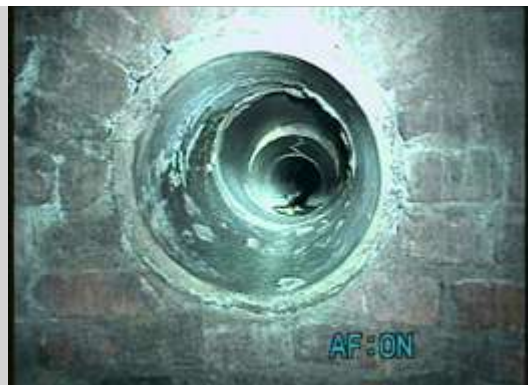
9 O'Clock Inflow

10 in. Circular Gravity Sewer
Pipe In @ 9 OClock

Pipe Material: **Clay** ☐ Pipe Lined

Infiltration: **None** Pipe Seal Cond: **Unknown**

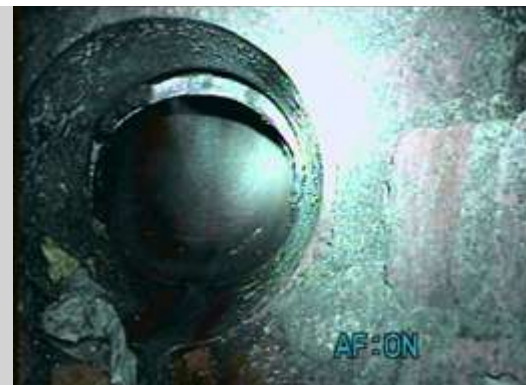
Drop In @ 9 OClock

Drop Condition: **Open**
